SOUTHWEST RESEARCH INST SAN ANTONIO TX  
DEVELOPMENT OF DIESEL ENGINE DIAGNOSTICS FOR U.S. COAST GUARD C--ETC(11)  
JUL 81 J O STORMENT, H S BENSON

16. Abstract This program involved an investigation of techniques to perform engine fault diagnosis on the large medium-speed diesel engines used as main propulsion power plants in medium- and high-endurance Coast Guard cutters. Two engine diagnostic parameters were defined and selected as the parameters of interest. They were (1) Instantaneous Crankshaft Angular Velocity (ICAV), which directly relates to the developed power contribution for each cylinder, (2) Dynamic Crankcase Pressure (PKD), which relates to the amount of gas leakage past the piston rings and into the crankcase. Prototype instrumentation was designed and developed to measure relative values of these parameters, and tests were conducted with several operating engines, some of them in Coast Guard cutters. Results of the development and test work were generally encouraging, but not definitive. This effort is therefore viewed as a step toward achieving the program goals. The report contains recommendations for further work.				13. Type of Report and Period Covered Final

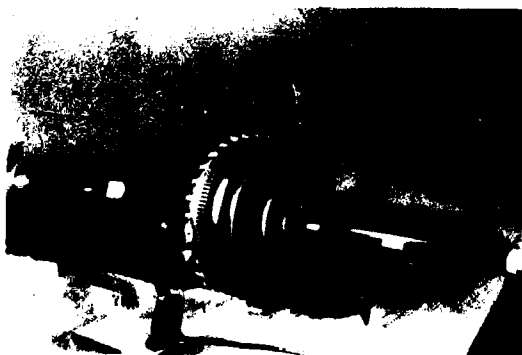
FIGURE 4.1 - VARIOUS VIEWS OF ICAV BENCH TEST RIG

signals. For this reason, the shaft encoder was used as the standard against which other measurement techniques were compared. This device (Model 30G900IDZPA1A, manufactured by Sequential Information Systems, Inc.) is ordinarily used in the direct mode where it produces 900 square wave cycles per revolution. The shaft encoder was used on the Enterprise test engine at SwRI (Section 5.1) during preliminary development work and also on test engines at the ALCO and Fairbanks Morse manufacturing plants (Sections 5.3 and 5.4). All three of these engines were coupled to alternators, and special adapters were fabricated to allow attachment of the shaft encoder to the rear of the alternator shaft. The difficulty (or outright impossibility) of satisfactorily attaching a shaft encoder to actual ship engines in the field necessitated development of a practical alternate angular velocity sensing means, and this situation resulted in development of the optical scanner system using ladder tapes which was alluded to earlier in the description of the bench test rig.

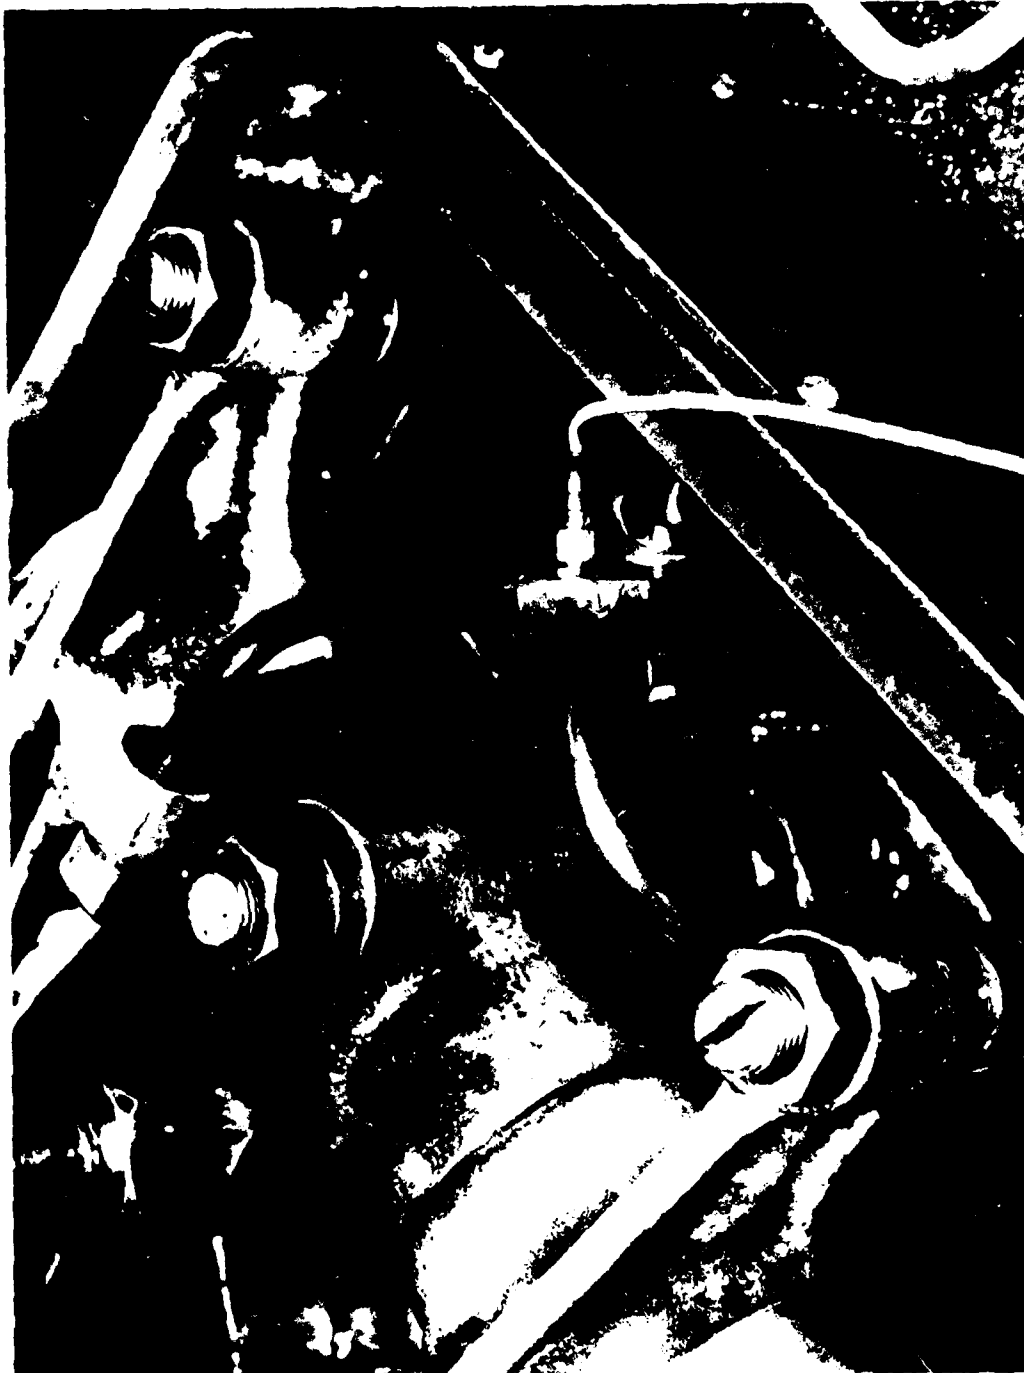
FIGURE 4.3 - TDC INDICATOR TRANSDUCER INSTALLED ON NO. 1  
CYLINDER INJECTION LINE

- Nominal TDC determination by means of simple instrumentation attached to the reference cylinder (usually No. 1 in the firing order) high-pressure fuel injection line was found to be quite practical. This technique of data synchronization (SYNCH) is a definite simplification over the usual magnetic pickup transducer method and proved adequate for all tests.
